**FOURTH FIVE-YEAR REVIEW REPORT FOR  
PINETTE'S SALVAGE YARD SUPERFUND SITE  
AROOSTOOK COUNTY, MAINE**

**U.S. Environmental Protection Agency  
Region 1  
Boston, MA**

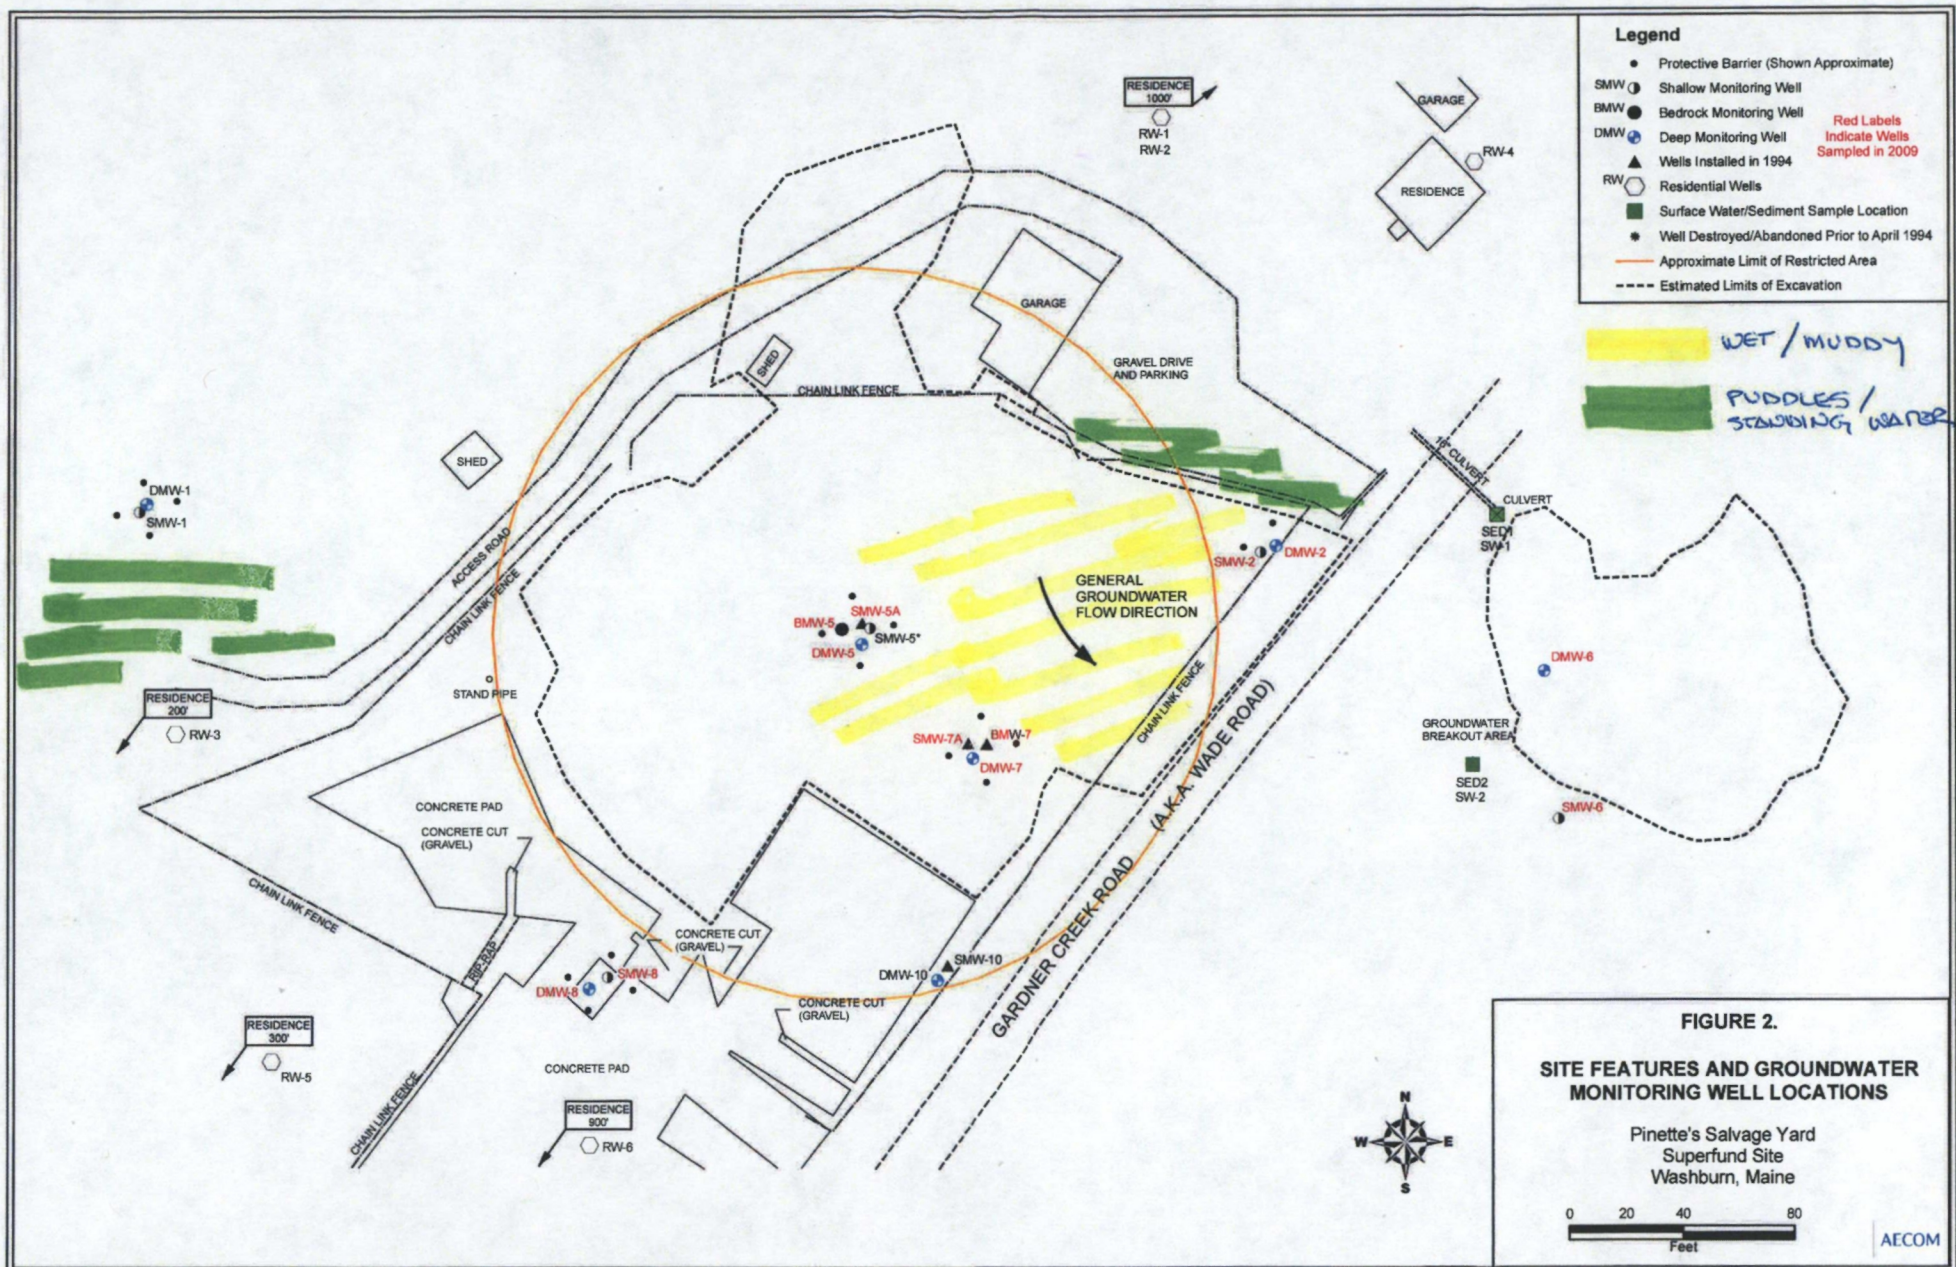
**Photo #1. MW-1 Well Cluster (Access is impeded by standing water, junked vehicles, and vegetation, and bollards are no longer vertical). May 2015.**
